# **INDOOR AIR QUALITY ASSESSMENT**

**Zervas Elementary School  
30 Beethoven Avenue  
Newton, Massachusetts**

Prepared by:  
Massachusetts Department of Public Health  
Bureau of Environmental Health Assessment  
Emergency Response/Indoor Air Quality Program  
September 2003

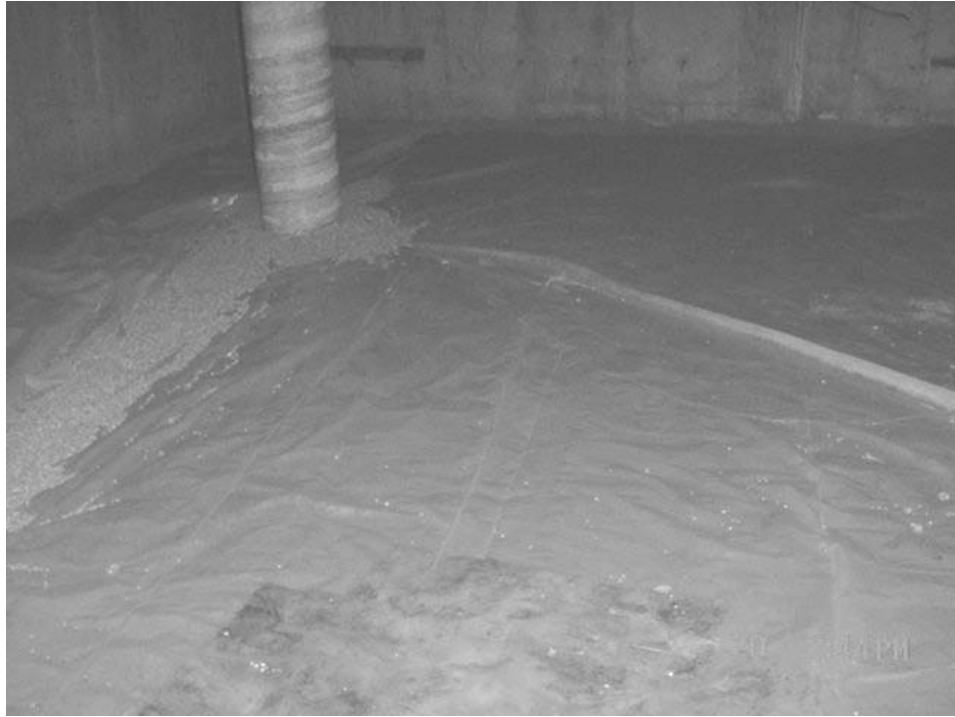
**Picture 1**

- Remediating mold contaminated materials;
- Repairing plumbing/steam leaks;
- Installing a vapor barrier on the crawlspace floor (Picture 1);
- Installing exterior bulkheads so interior access plates could be sealed;

**Plastic Polyethylene Vapor Barrier Installed in Crawlspace**

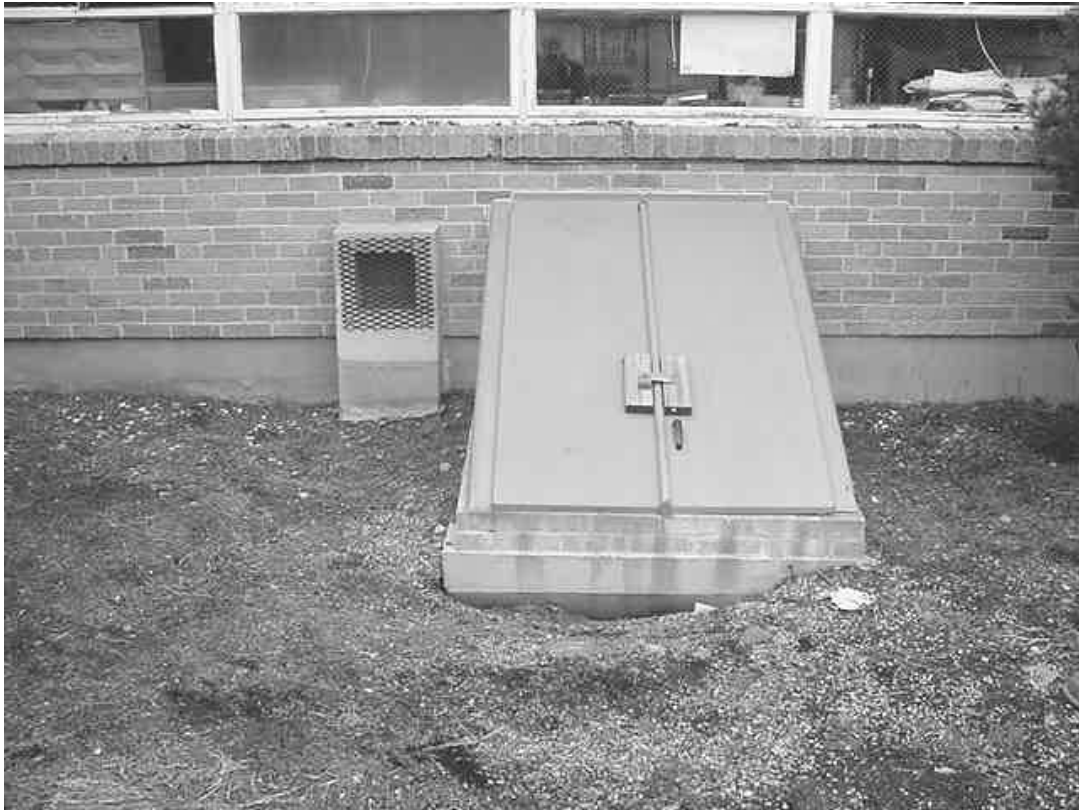
**Picture 2**

**Bulkhead Installed for Crawlspace Access**

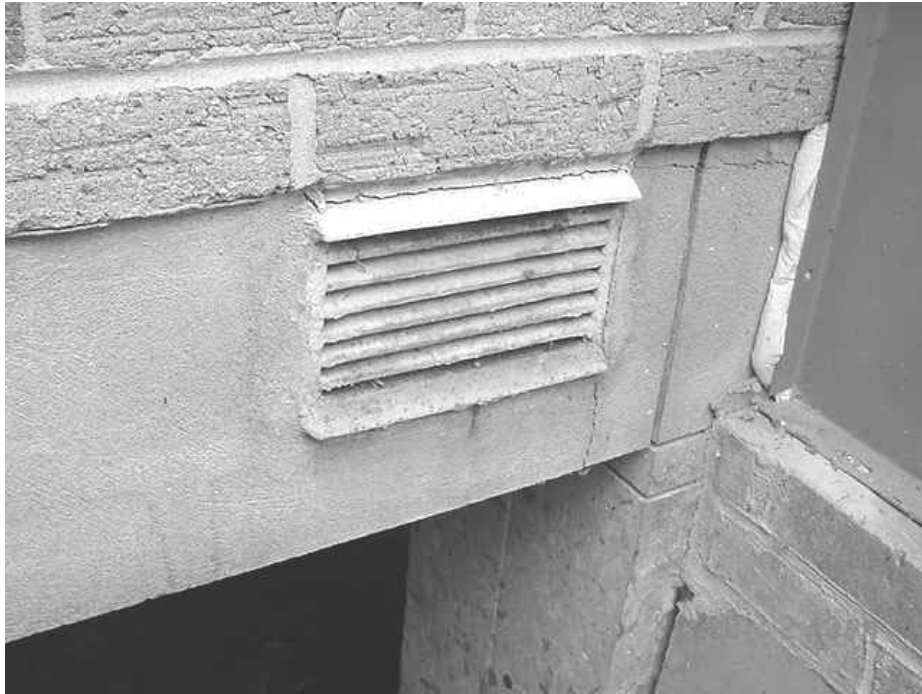
**Picture 3**

**Passive Crawlspace Vent (Make-Up Air)**

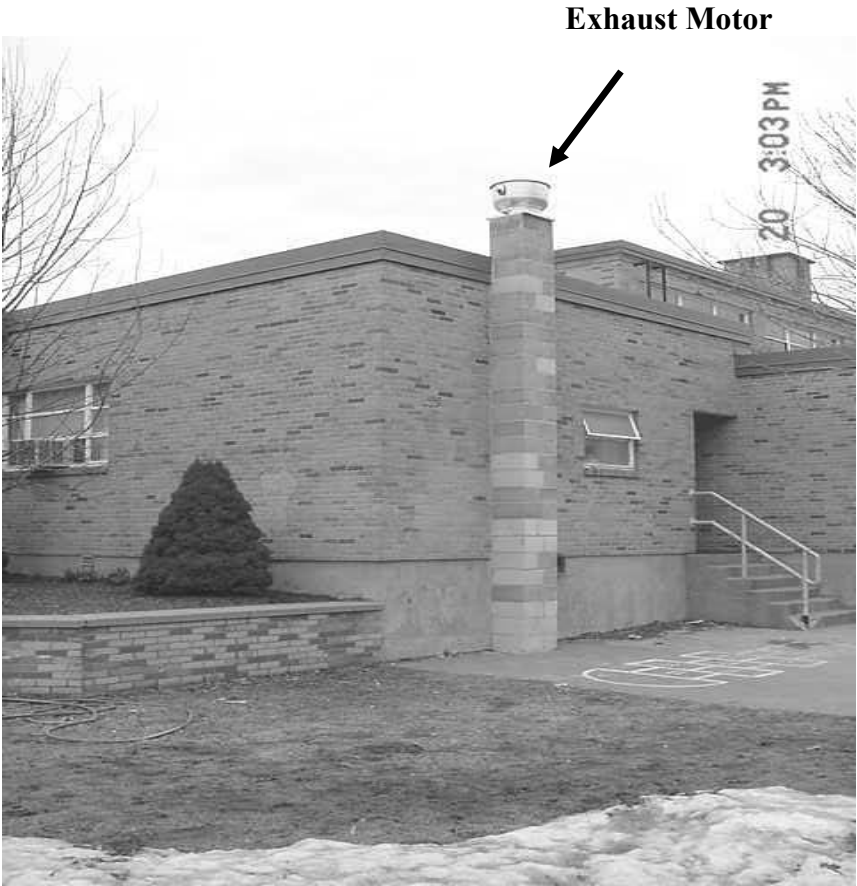
**Picture 4**

**Mechanical Crawlspace Exhaust Vent/Chimney**

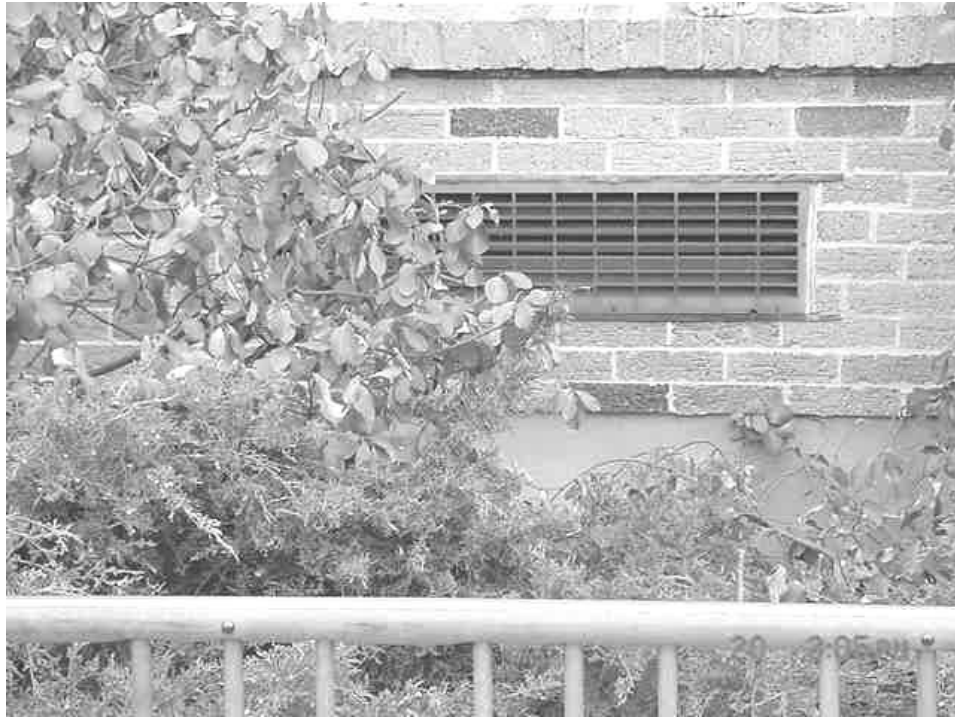
**Picture 5**

**Univent Fresh Air Intake, Note Close Proximity of Foliage**

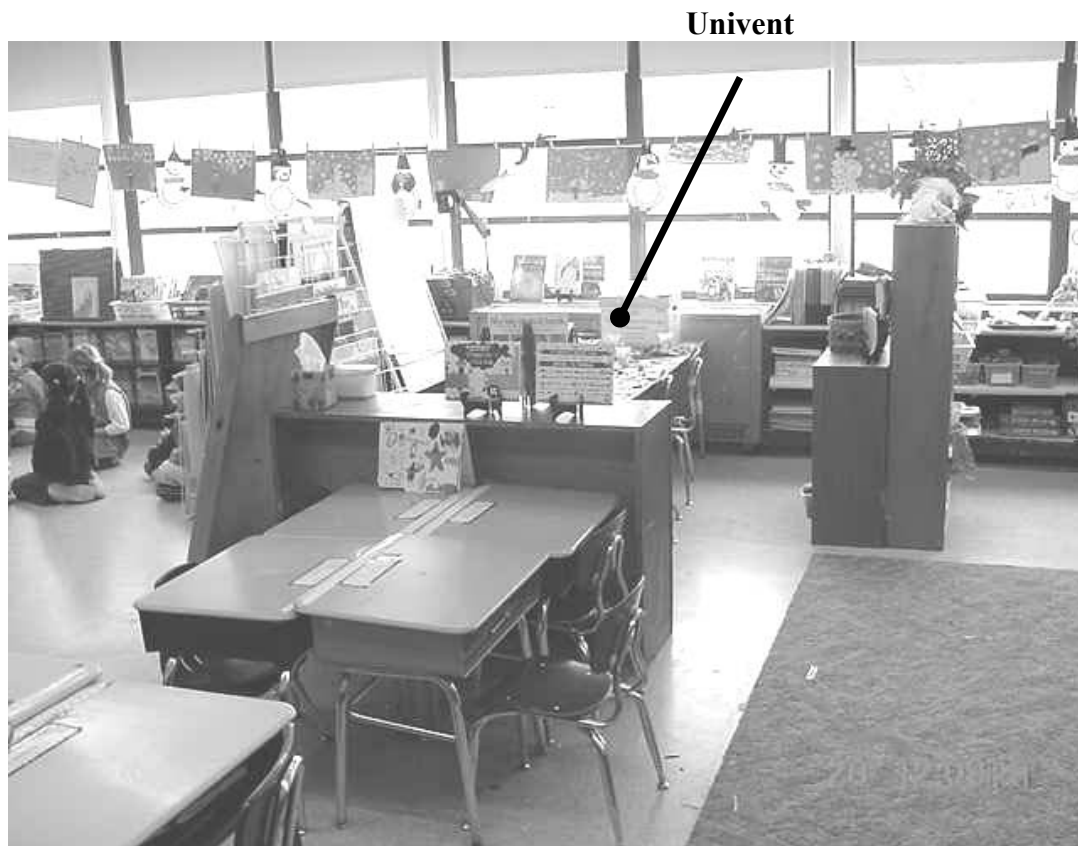
**Picture 6**

**Classroom Furniture Configured around Univent Obstructing Airflow**

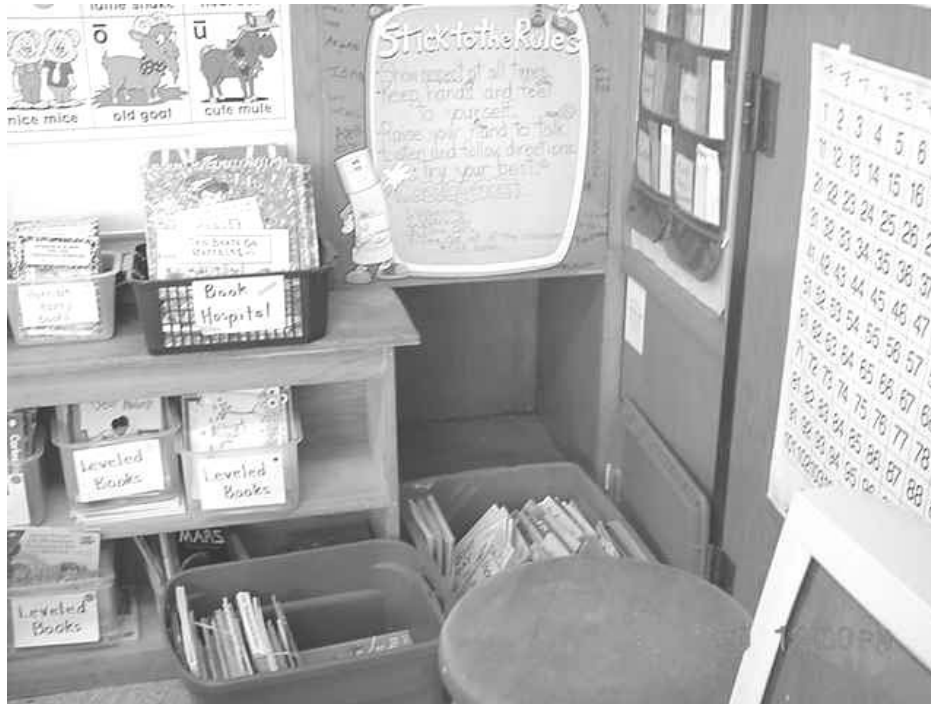
**Picture 7**

Exhaust ventilation is provided by a mechanical system, which draws air into an ungrated hole located at floor level in classrooms (Picture 7). Airflow is controlled by a flue located inside the duct. Exhaust vents were operating in most of the classrooms surveyed. No draw was detected in the music room and room 1L-3, which can indicate that the system was deactivated or not operable. BEHA staff examined conditions on the roof and found that the belt to exhaust motor L-3 was loose. Items were also seen obstructed a number of exhaust vents in classrooms

**Exhaust Vent/Ungrated Hole**

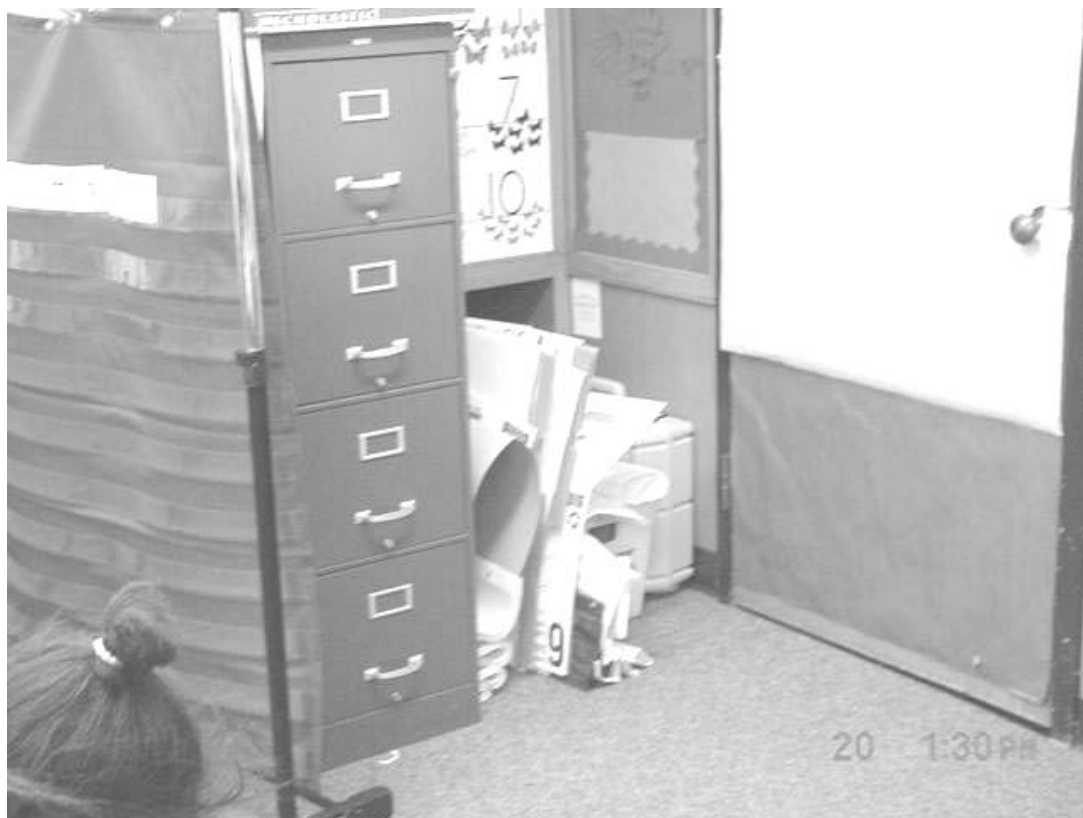
**Picture 8**

(Picture 8). As with the univents, exhaust vents must remain free of obstructions to function as designed.

**Exhaust Vent/Ungrated Hole Used for Classroom Storage**

1. Remediate section of pipe in crawlspace in conformance with all applicable Massachusetts asbestos abatement and hazardous materials disposal laws.
2. Remove all blockages from univents and exhaust vents. Clean out interiors of univents regularly (e.g. with filter changes).
3. Operate both supply and exhaust ventilation continuously during periods of school occupancy, independent of classroom thermostat control.
4. Inspect rooftop exhaust motors and belts for proper function. Repair and replace as necessary.
5. Examine exhaust vent in boy's restroom near the Principal's office for proper function. Repair and replace as necessary.

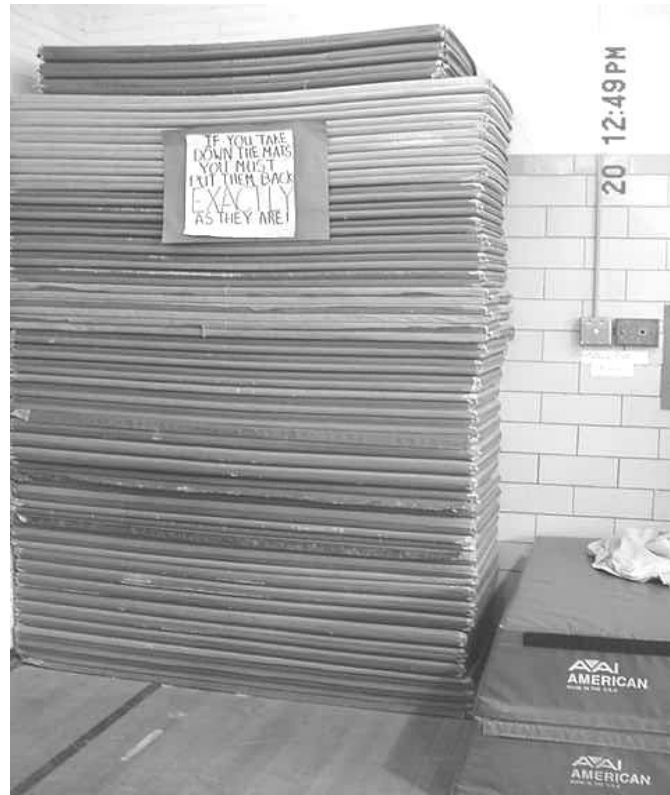
**Picture 9**

Exhaust ventilation in the gym is provided by a wall mounted-grill that was blocked by exercise mats (Picture 9). This system was deactivated during the assessment. In order to function as designed, exhaust ventilation must remain activated. Restrooms are equipped with ceiling and/or wall-mounted exhaust vents. The exhaust vent in the boy's room near the Principal's office appeared to be "blowing" air instead of "drawing".

**Exercise Mats Obstructing Exhaust Vent**

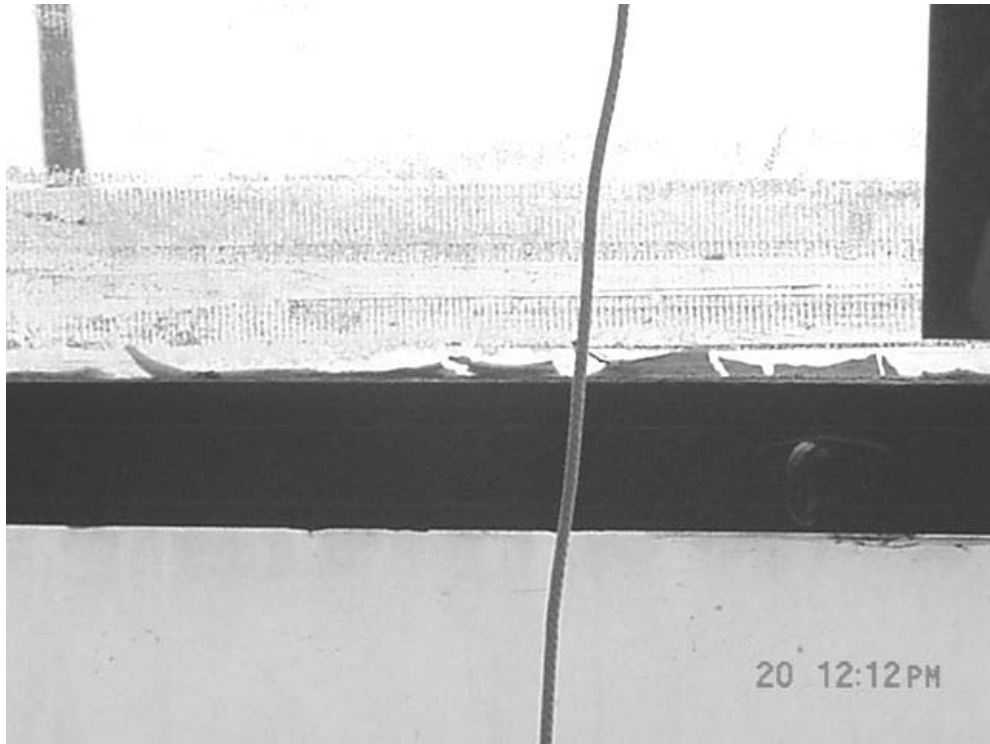
**Picture 10**

Caulking around windows was missing/damaged in many areas (Pictures 10 & 11). Missing caulking and/or loose fitting windowpanes can create difficulties in temperature control

(e.g. drafts). Furthermore, spaces around window panes/frames can allow for water penetration, which can lead to water damage and subsequent mold growth.

**Peeling/Damaged Caulking, Interior of Window**

10. Repair/replace loose/broken windowpanes and missing or damaged window caulking building-wide to prevent water penetration through window frames. During this project it is recommended that all water-damaged materials be examined for microbial growth and structural integrity. Repair water damaged ceilings, walls and wall-plaster as necessary.

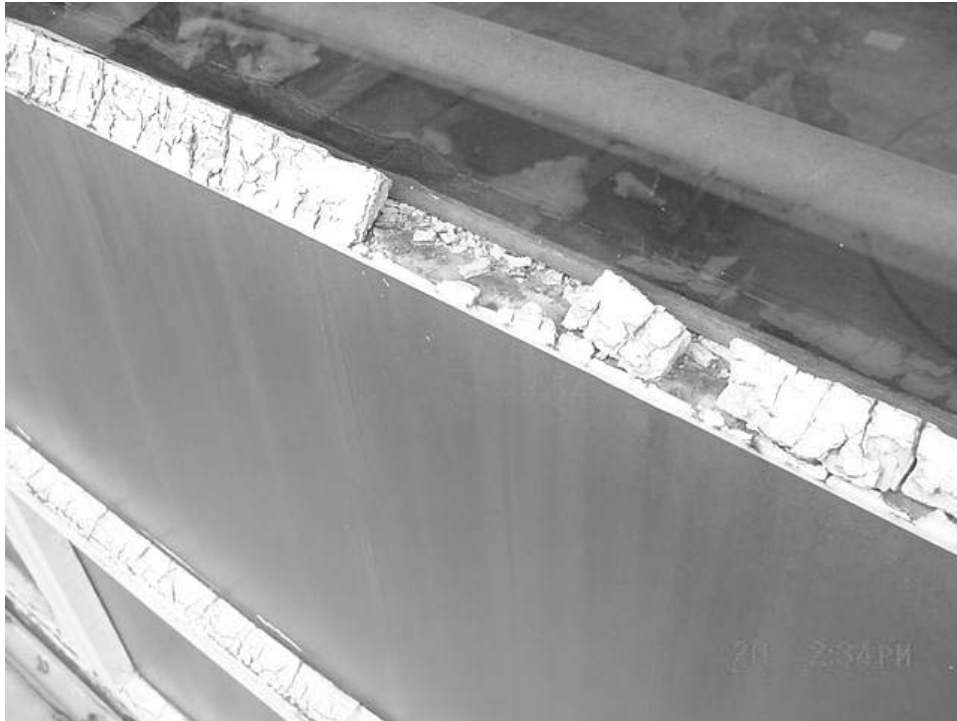
**Picture 11**

**Missing/Damaged Caulking on Exterior of Window**

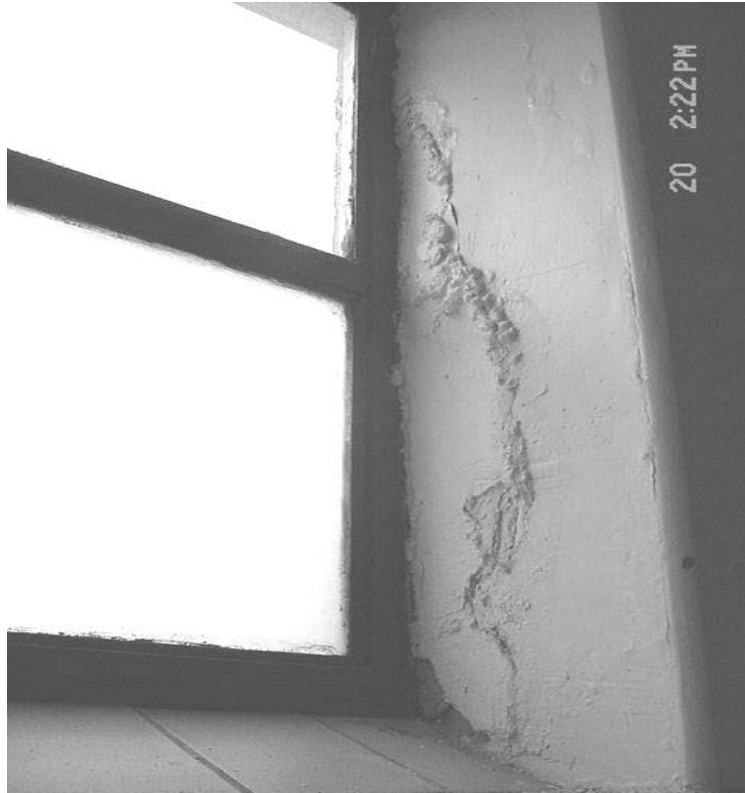
**Picture 12**

Efflorescence (i.e. mineral deposits) was observed on windowsills (Picture 12).

Efflorescence is a characteristic sign of water damage to building materials such as brick or plaster, but it is not mold growth. As moisture penetrates and works its way through mortar around brick, water-soluble compounds in bricks and mortar dissolve, creating a solution. As the solution moves to the surface of the brick or mortar, water evaporates, leaving behind white, powdery mineral deposits. This condition indicates that water from the exterior has penetrated into the building. In this case the most likely source of water penetration is around window frames.

**Efflorescence (Mineral Deposits) on Interior of Window**

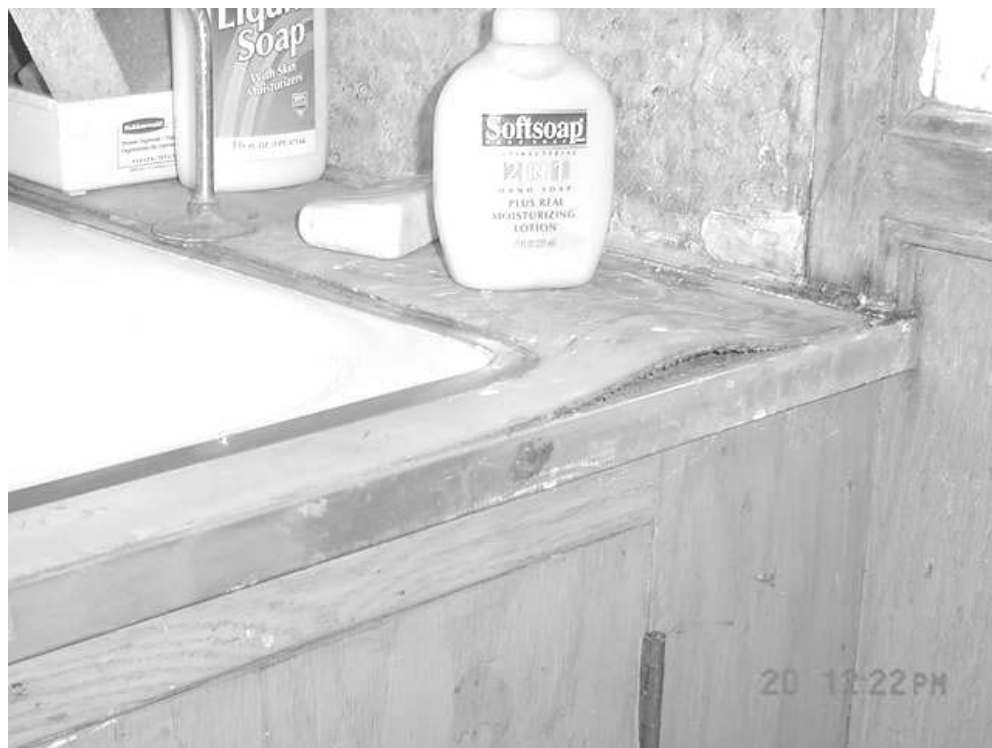
**Picture 13**

Spaces between the sink countertop and backsplash were noted in some classrooms (Picture 13). Improper drainage or sink overflow could lead to water penetration of countertop wood, the cabinet interior and behind cabinets. If porous materials become wet repeatedly they can provide a medium for mold growth.

**Peeling Countertop of Classroom Sink**

11. Seal areas around sinks to prevent water-damage to the interior of cabinets and adjacent wallboard. Disinfect areas of microbial growth with an appropriate antimicrobial as needed. Consider replacing with one-piece, molded countertops.

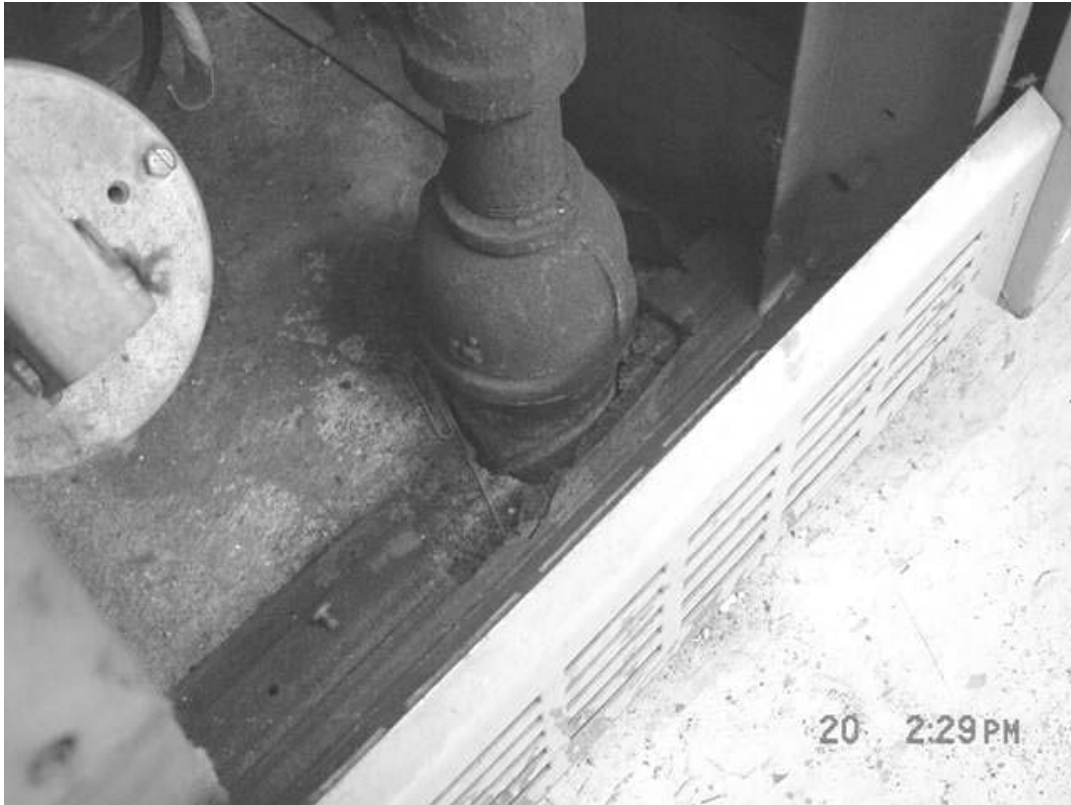
**Picture 14**

The interiors of several univents were examined. Spaces around heating pipes were observed (Picture 14). Spaces of this nature can result in the univent drawing air and debris from the crawl space and distributing these materials to the interior of the building.

**Spaces around Utility Pipes in Univent Casing**

12. Seal wall and pipe floor holes within univent casing.
13. Store cleaning products properly and out of reach of students.
